Final
DECISION DOCUMENT
UST SITE 130

117th Refueling Wing
Alabama Air National Guard
Birmingham Airport
Birmingham, Alabama

January 1997

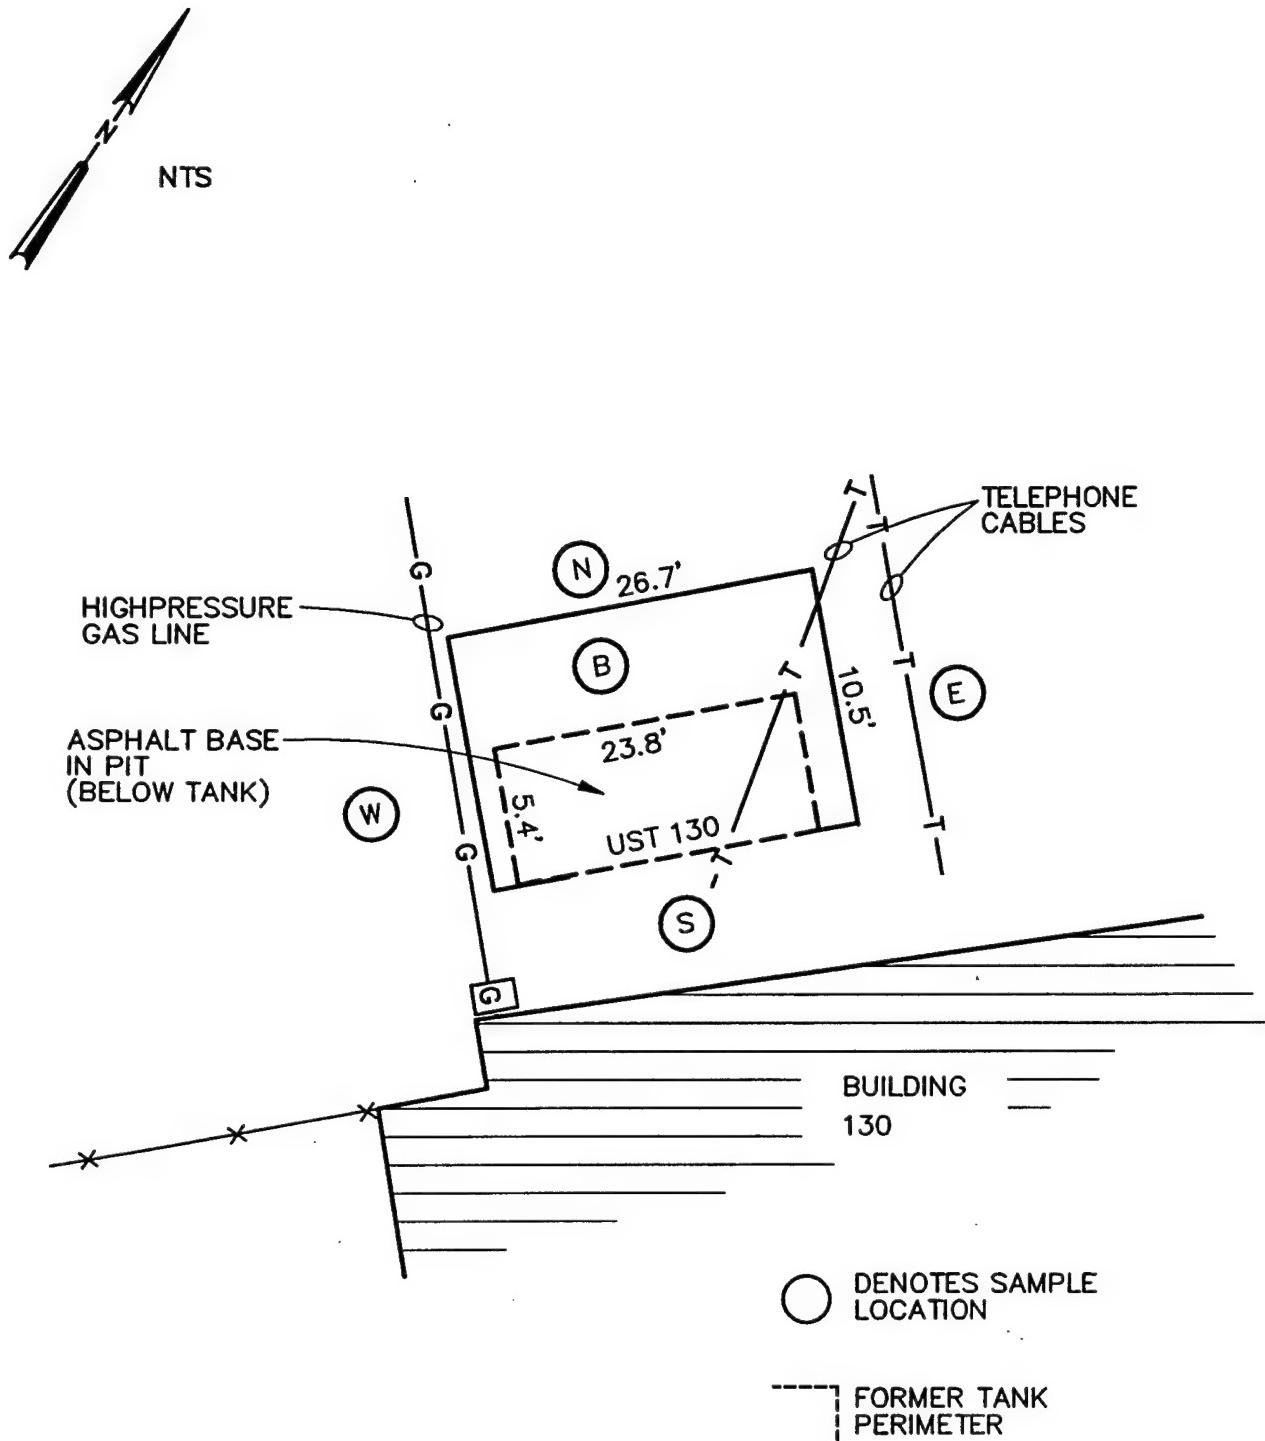
FIGURE 3
UST 130 SITE MAP
Alabama Air National Guard, Birmingham, Alabama

UST 130 appeared to be in good condition upon removal, although it had one hole on the northern side of the western end. Only a small amount of odor was detected during the UST excavation. Soils from the southern edge of the excavation directly adjacent to the tank were not removed to avoid possible foundation problems with an adjacent building.

HNu HEADSPACE READING	
LOCATION	(ppm)
130-N	4
130-S	28
130-E	3
130-W	4
130-B	44
130-SP	30

The soil in the UST 130 pit was found to be a reddish clay with mixed stone. Eighteen inches of crushed aggregate were overlying the clay materials with an asphalt pavement at the surface. The moisture content in the soils increased with depth, but the static water table is believed to be at or near the base of the pit (8.5 feet).

Field screening tests (headspace readings) for the soils remaining in the excavation did not indicate large amounts of soil contamination, and the excavation was backfilled. No soil was removed from the excavation for offsite disposal.
